## Tech Notes

**Title:** Battery failure initializes the controller

**Applies To:** All 2100 controllers

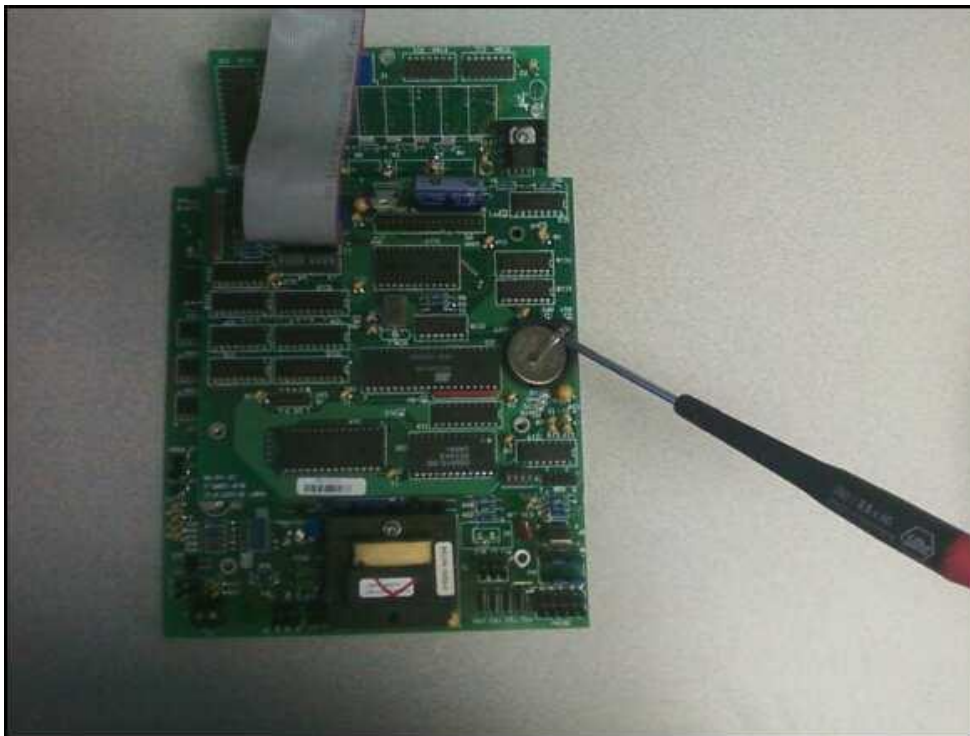
**Problem Description:** The 2100 controller initializes during boot up and/or will not keep the parameters stored in memory

Battery number BR2330, Fluke item: 2135249

**Resolution/Work Around:** The 2100 controller 3V battery level must be above 2.8V. At 2.7V the battery does not have enough power to maintain the memory. New batteries should be around 3.3V to sustain the operation for a few years.
