# Test Report

Report No. A218023276910104

Sample Name Thermalert4.0series infrared sensors  
Material 316L  
Sample Receiving State Normal  
Sample Received Date Nov. 27, 2018  
Testing Period Nov. 27, 2018-Dec. 4, 2018

**Test Item: IP6X**

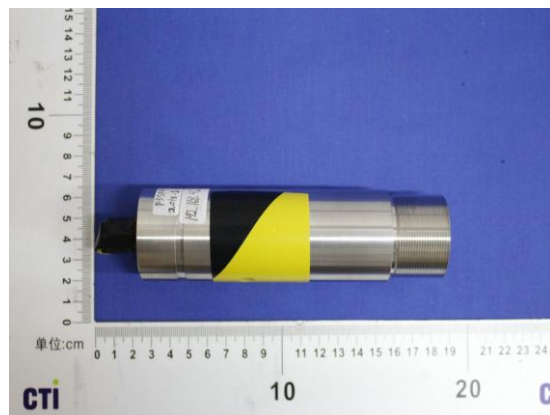
Sample No.	Sample Name	Material	Quantity
A2180232769101003	Thermalert4.0series infrared sensors	316L	1pc

## Sample Photo(s)

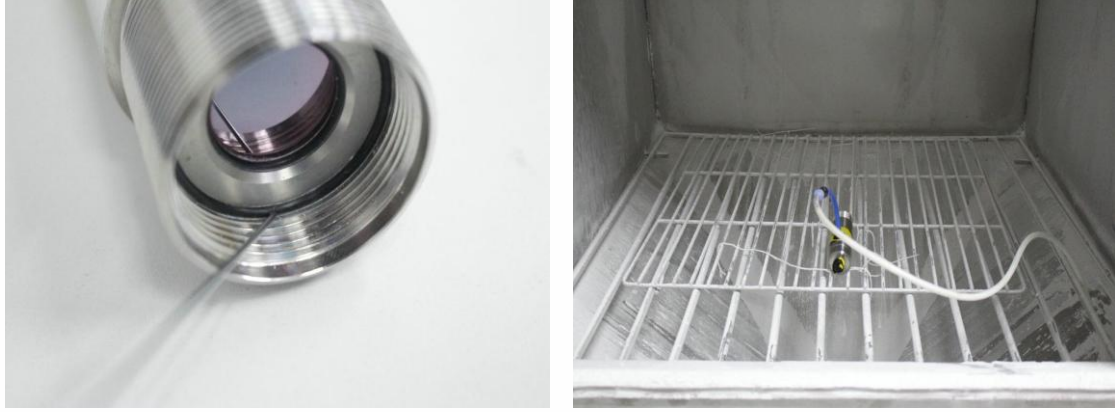
A2180232769101003

The Test prober of 1 mm diameter is pushed against any opening of the sample with force of 1 N

Set the sample in the dust chamber, the pressure inside the enclosure is maintained below the surrounding atmospheric pressure by a vacuum pump (Pump speed:96mL/min, 40-60times of the shell volume per hour; the differential pressure between the containment and the atmosphere: 0.3kPa)

## Test Photo(s)

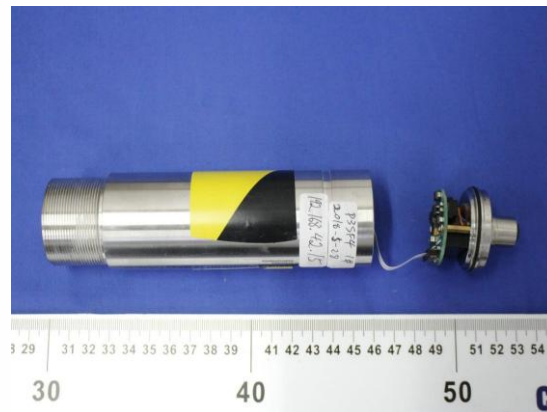
Sample No.	Test result (Visual inspection)	Conclusion
A2180232769101003	The test probe cannot enter into the sample, no dust entered into the sample	Pass

## Sample Photo(s) after the test
