Linescanner Machine Alignment Checking/Causes/Effects

Examples of Misalignment and Possible Consequences to Thermal Profile

By Adam Ellis

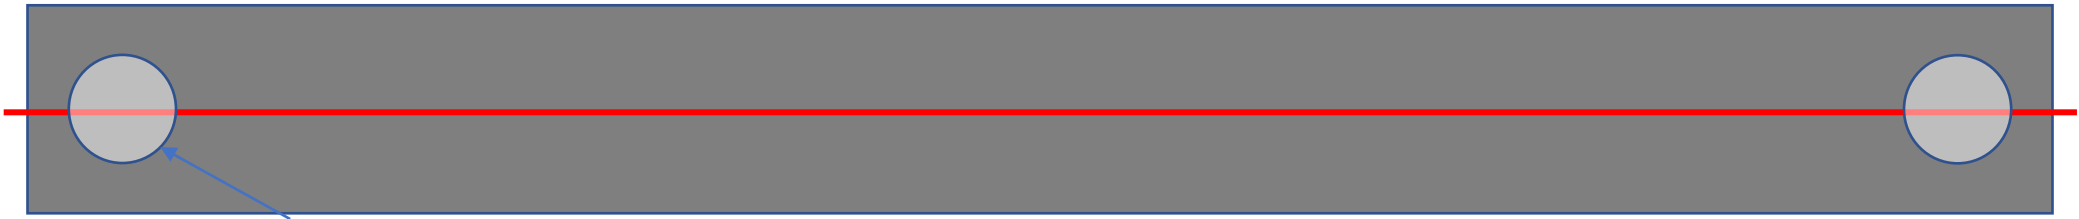
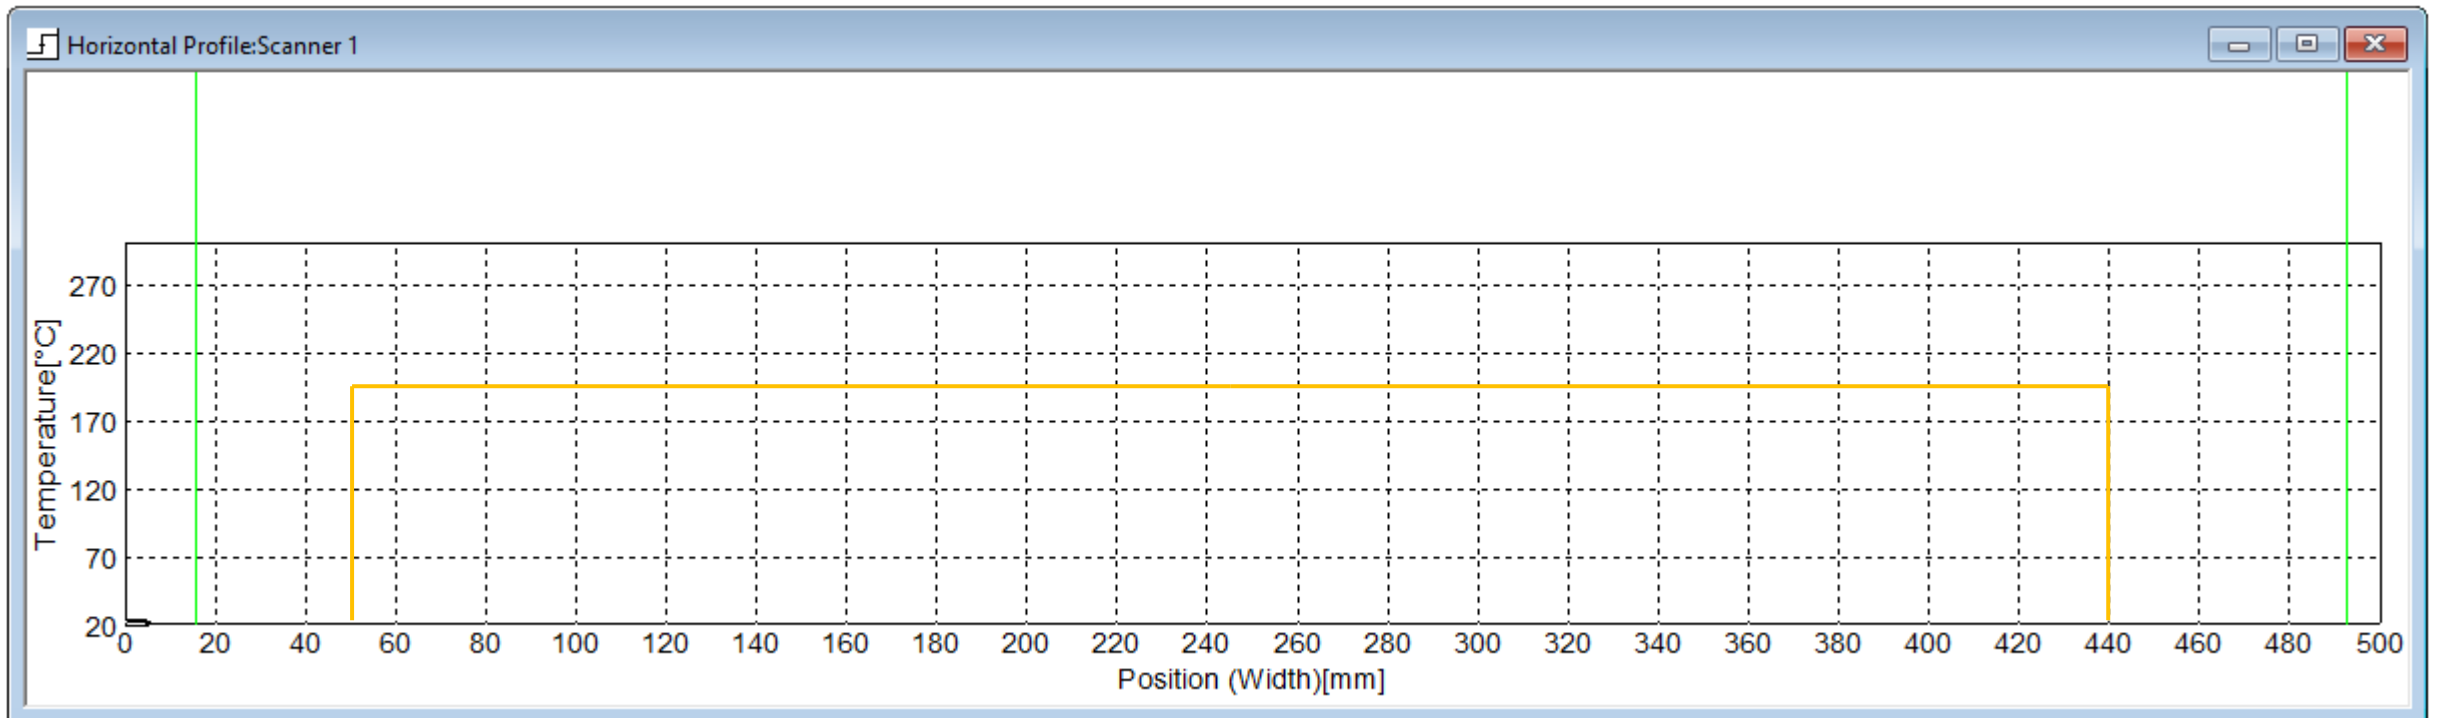
Ideal Alignment to slit aperture

(assuming aperture was aligned during machine construction)

General assumption that spot size diameter < slit (aperture) height – spot energy not reduced

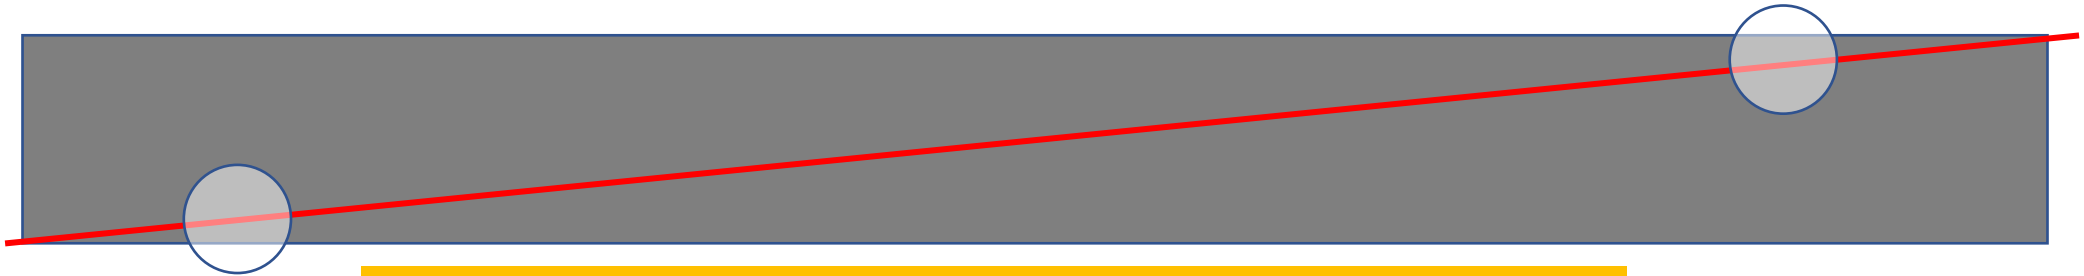
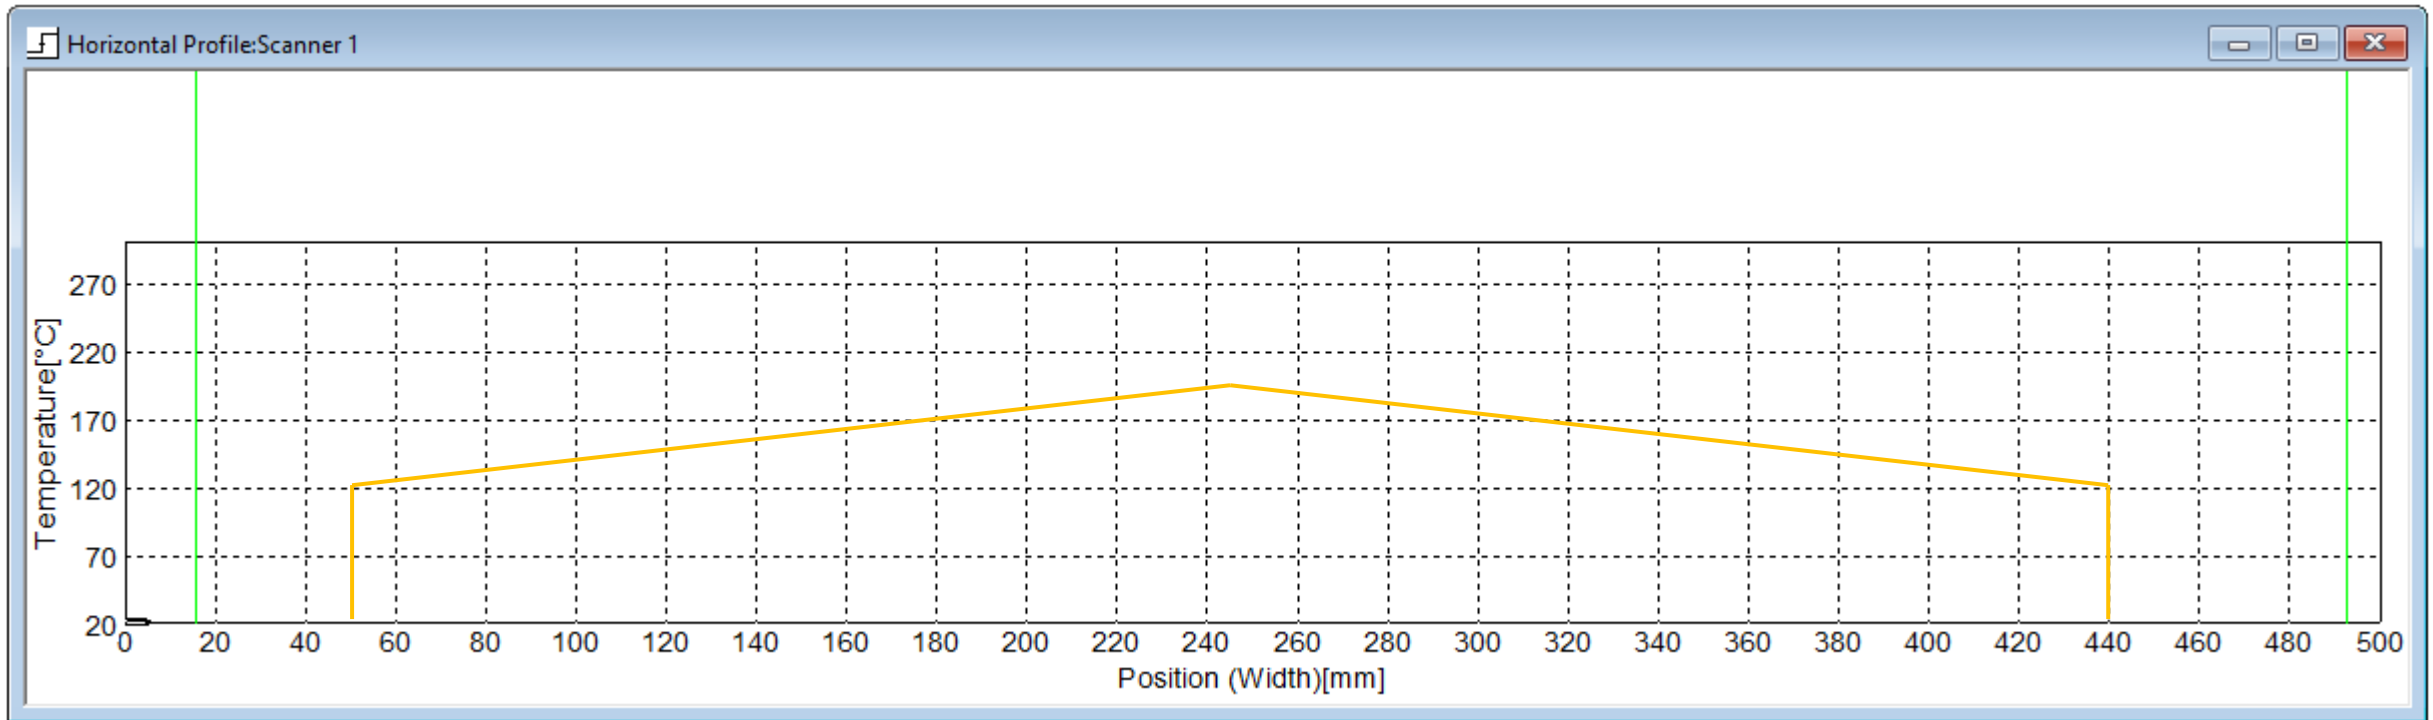
Concentrically Rotated Alignment to slit aperture

Spot energy reduced – increasing towards edges on both sides

Concentrically Rotated Alignment to slit aperture

Spot energy reduced – increasing towards edges on both sides

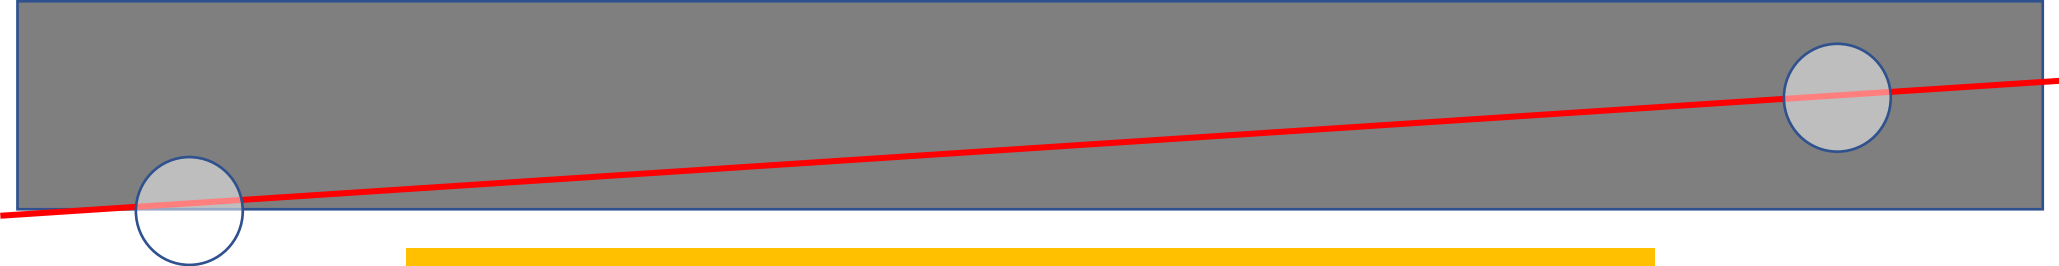
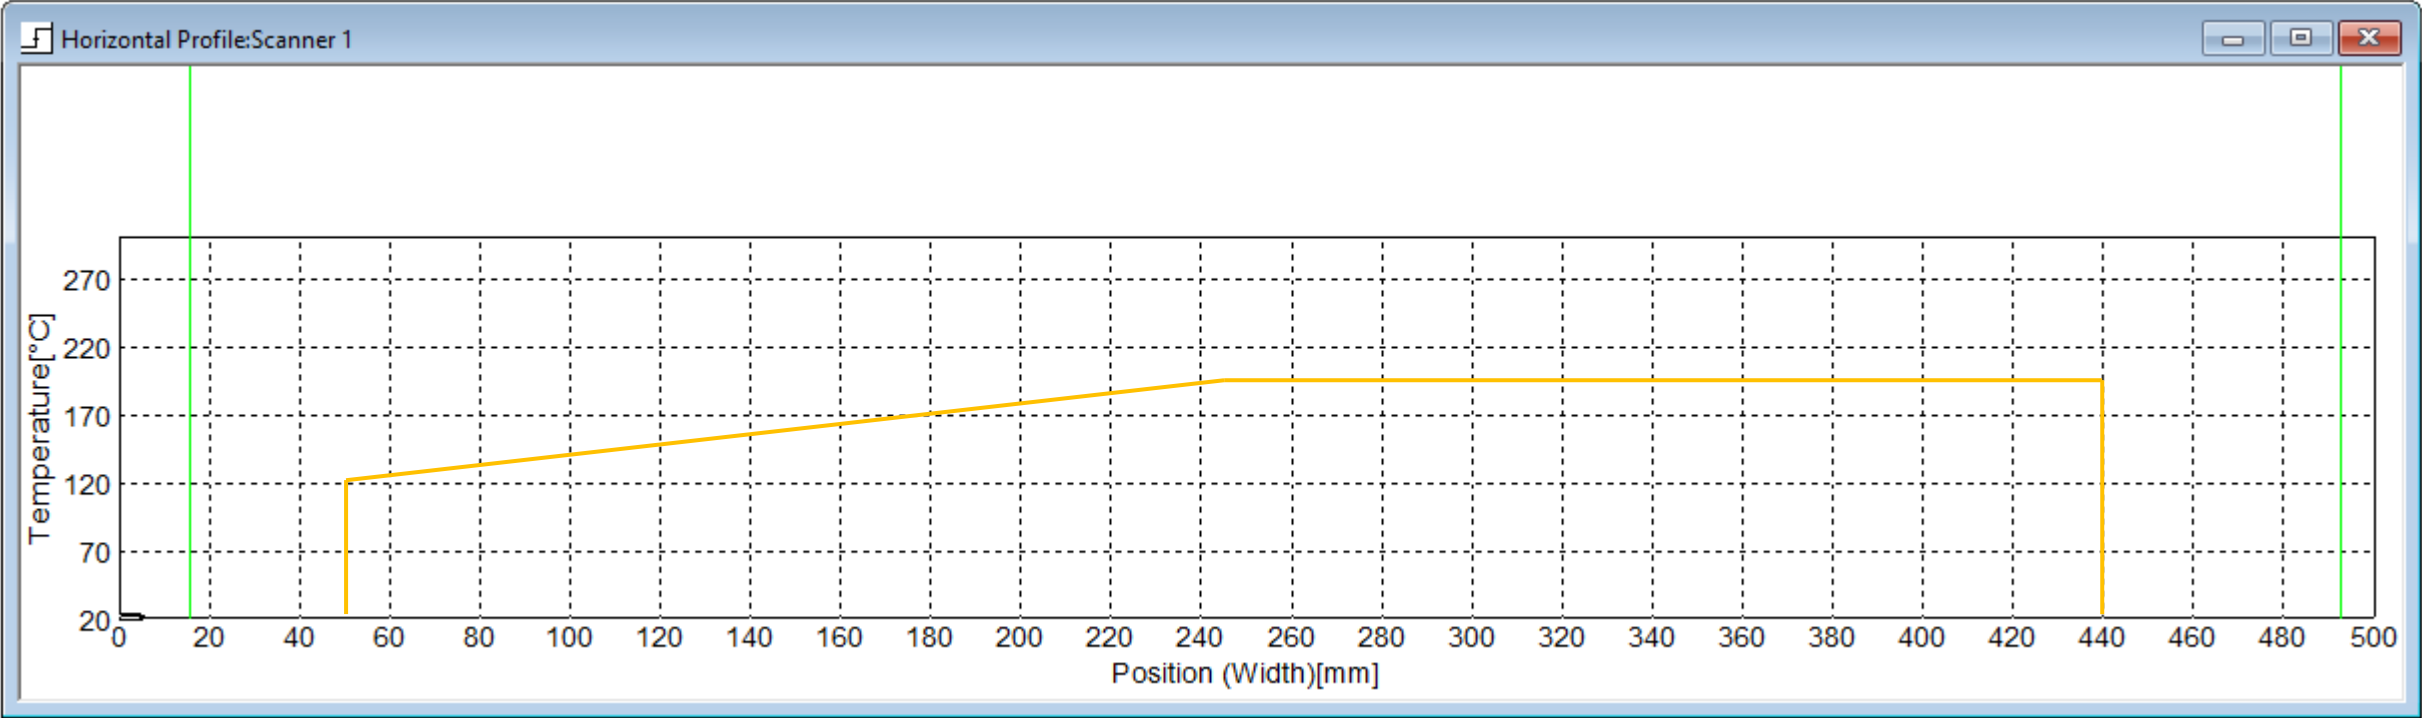
Non-Concentrically Rotated Alignment to slit aperture

Spot energy reduced – increasing towards edge on one side

Non- Concentrically Rotated Alignment to slit aperture

Spot energy reduced – increasing towards edge on one side

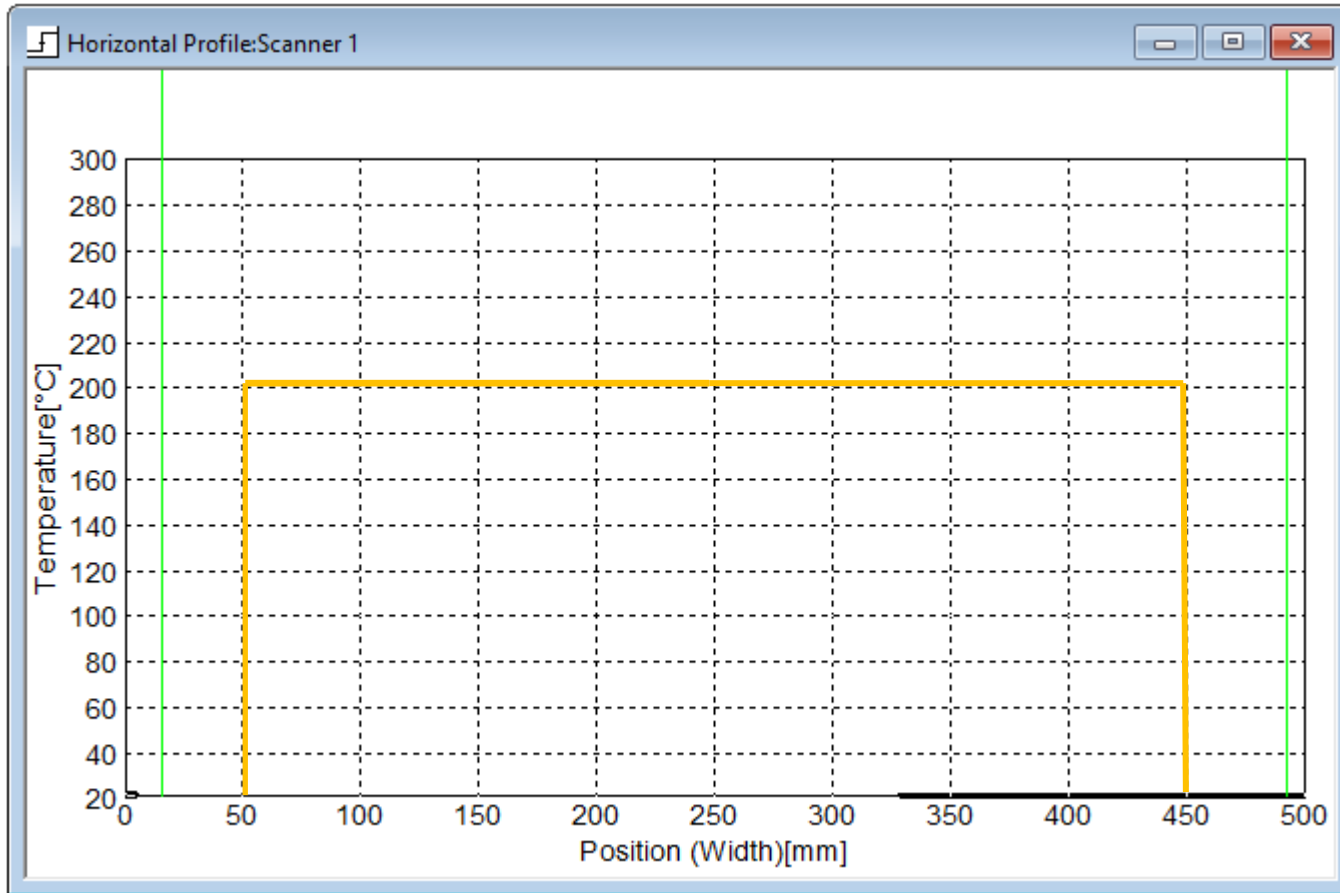
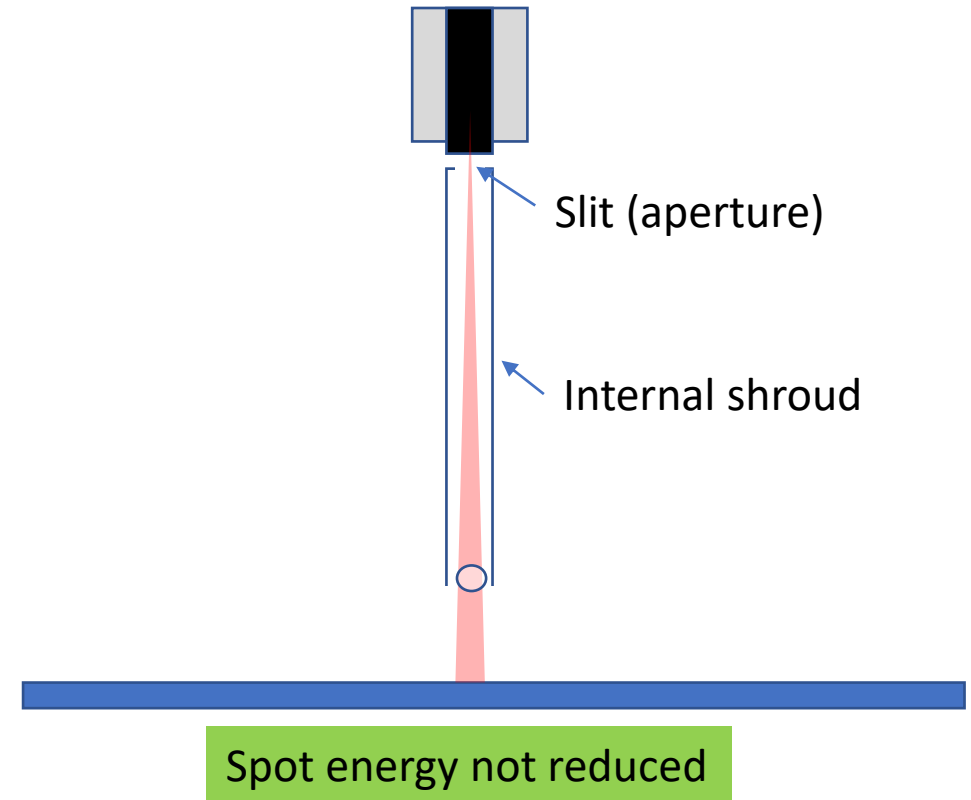
Ideal - Not Tilted - Looking Down

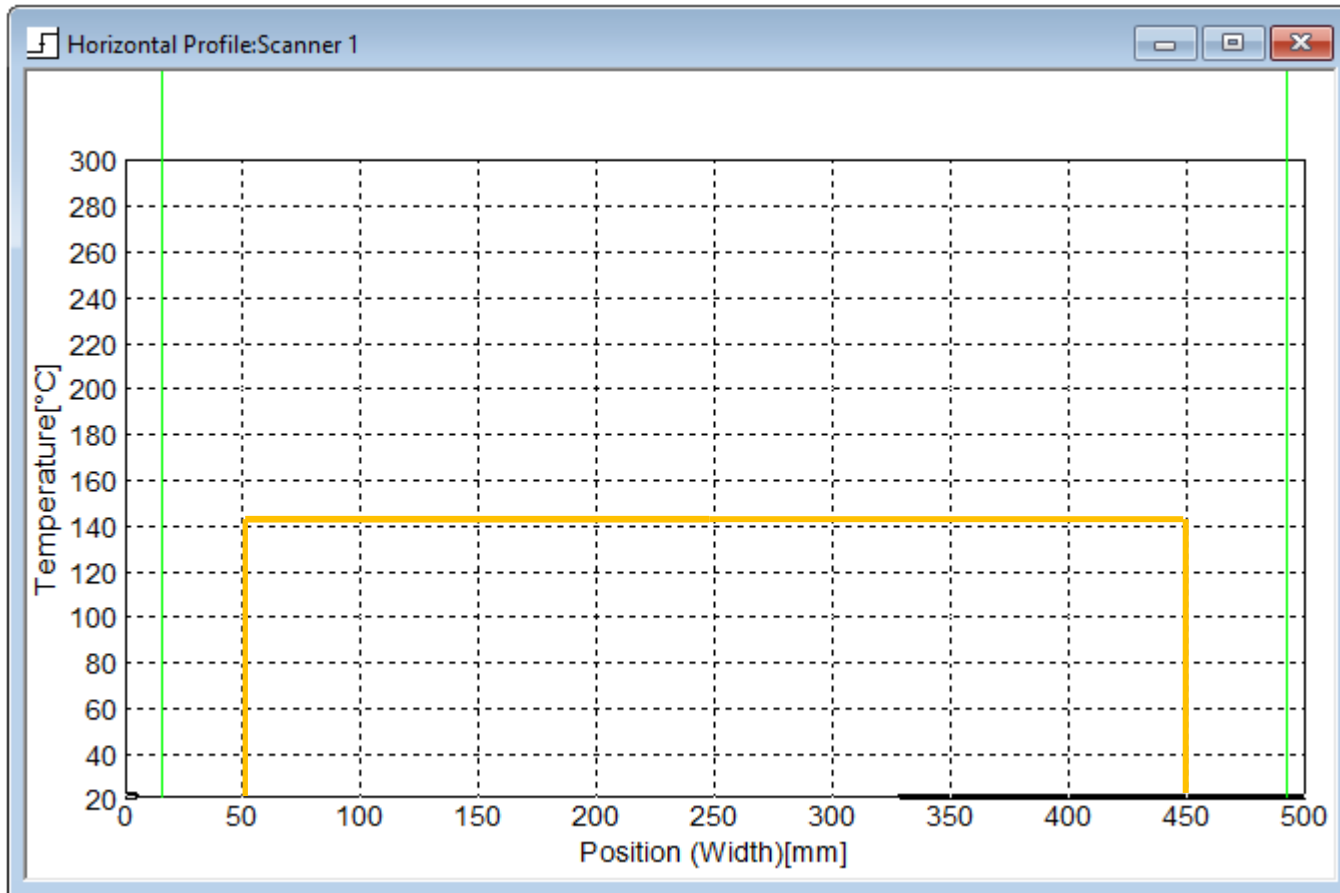
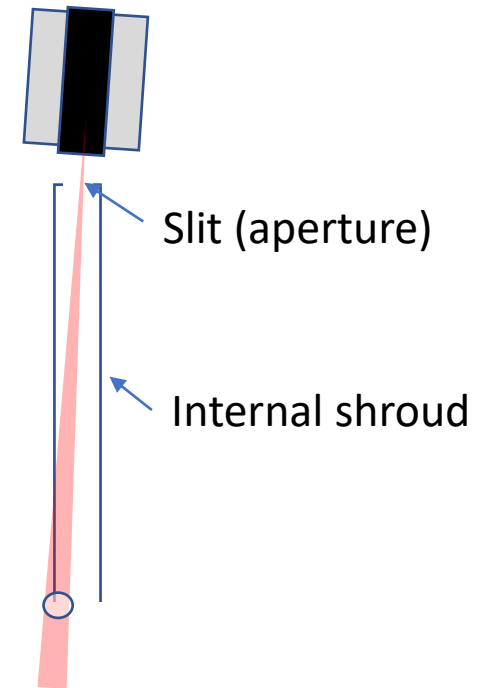
Problem – “Tilted” - Looking Down

Spot energy reduced across complete scan line

Problem – “Tilted” - Looking Down

Spot energy reduced across complete scan line
